PERTLE SPRINGS LAKE DAM

JOHNSON COUNTY, MISSOURI

PHASE 1 INSPECTION REPORT NATIONAL DAM SAFETY PROGRAM

PERTLE SPRINGS LAKE DAM
JOHNSON COUNTY, MISSOURI
MISSOURI INVENTORY NO. 20044

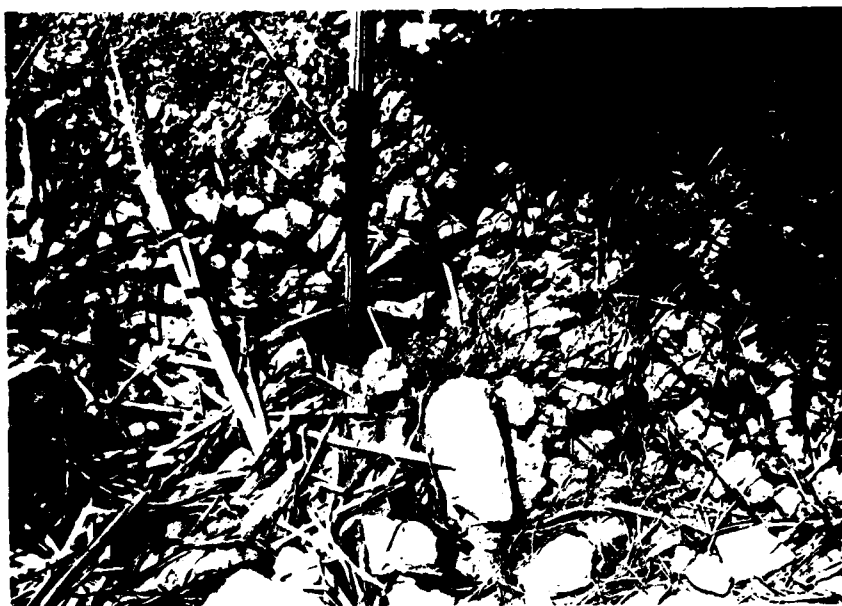
Many animal burrows were observed on the embankment. The area considered as the upstream channel to the lake contains several small dams and lakes located in an area of low hills. The lake water was noted to be clear containing a minor amount of siltation.

Burrowing animals will continue to damage the embankment if no program is undertaken to eliminate them. Piping failure of the embankment has resulted in similar small earth dams due to burrowing animal damage.

PHOTO 13: ANIMAL BURROW IN UPSTREAM FACE OF DAM

(3) The animal burrows in the embankment should be repaired since they can lead to piping. Control measures should be implemented to discourage animal activity in the area.
